# REFORMER AND SHIFT CATALYST EXPERIENCE

# AMMONIA PLANT

# Catalyst Upset – Case Study

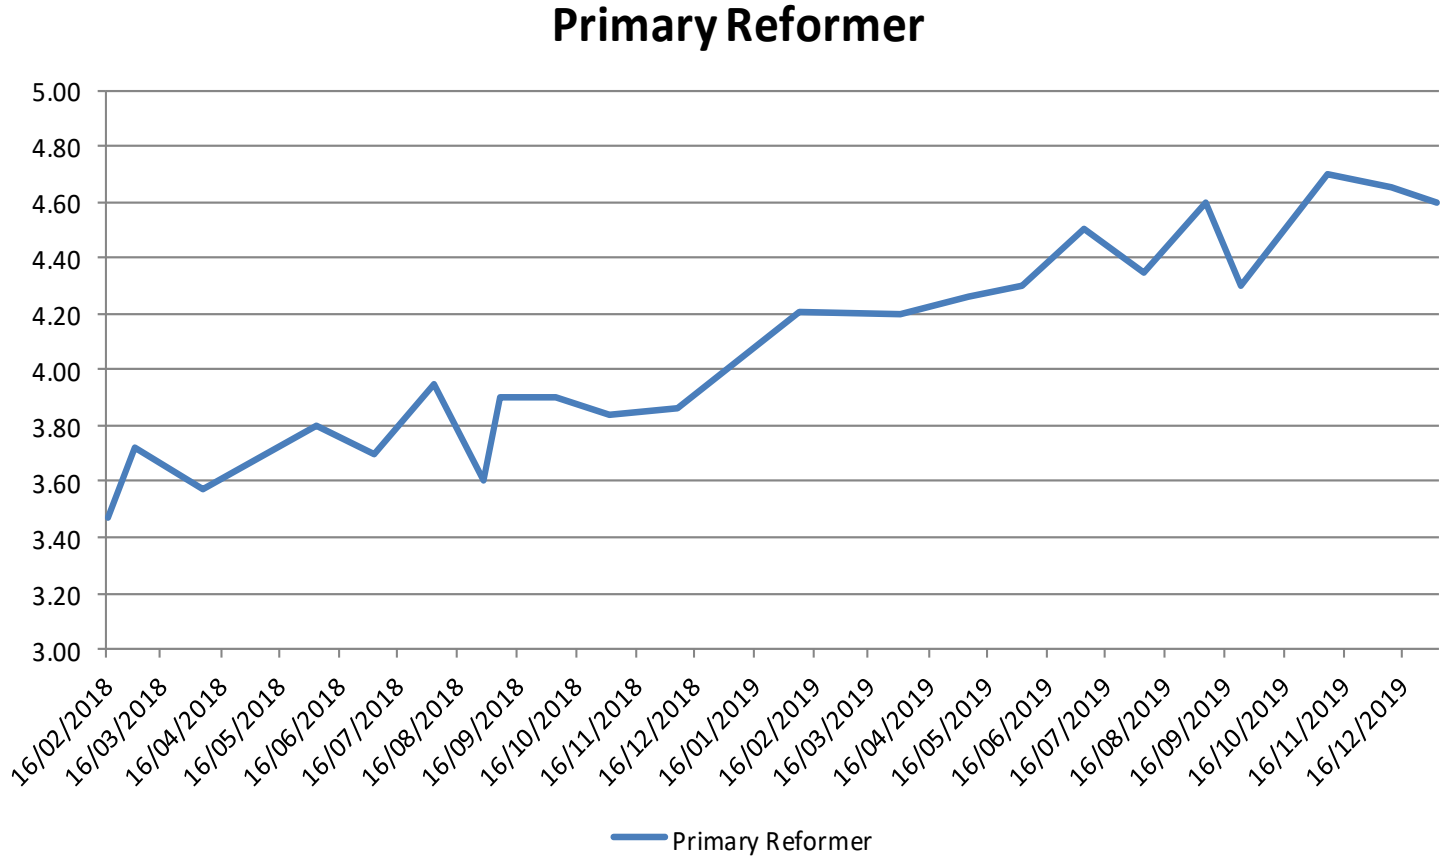
# REFORMER – CASE STUDY

Date	Primary Reformer
16/02/2018	3.47
02/03/2018	3.72
06/04/2018	3.57
04/06/2018	3.80
04/07/2018	3.70
03/08/2018	3.95
29/08/2018	3.60
07/09/2018	3.90
05/10/2018	3.90
02/11/2018	3.84
07/12/2018	3.86
08/02/2019	4.21
01/04/2019	4.20
06/05/2019	4.26
03/06/2019	4.30
05/07/2019	4.50
05/08/2019	4.35
05/09/2019	4.60
24/09/2019	4.30
07/11/2019	4.70
10/12/2019	4.65
03/01/2020	4.60
